## **Realistic Safe-Separation Distance Determination for Mass Fire Hazards**

by  
Thomas L. Boggs  
*New Directions Technology, Inc.*  
*Ridgecrest, CA 93555*

**MARCH 2013**

NAVAL AIR WARFARE CENTER WEAPONS DIVISION  
China Lake, CA 93555-6100

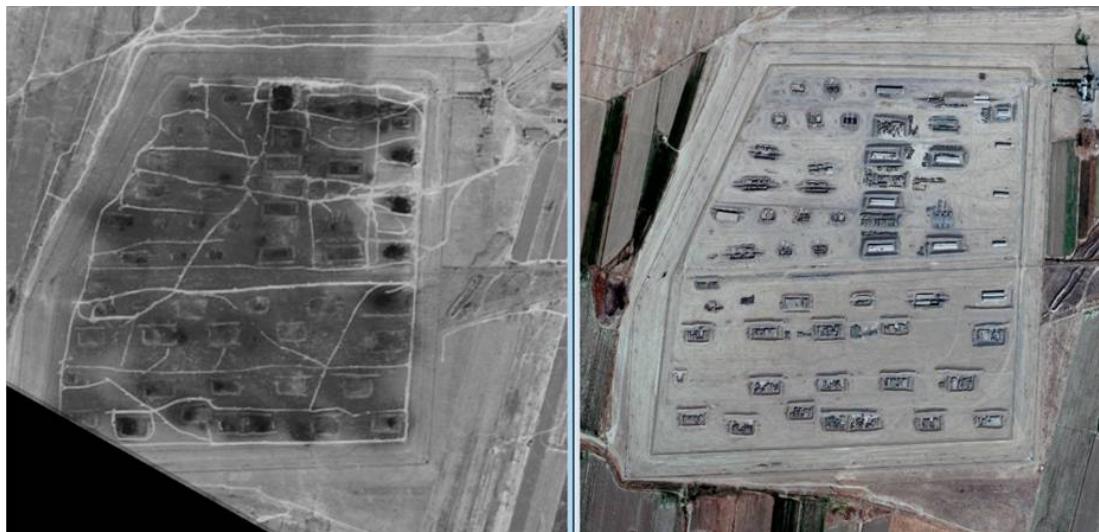
ScanEx, a Russian satellite company, published the before and after images of the military depot where fires and explosions occurred shown in Figure 63. The photograph on the right clearly shows the buildings within the depot before the accident, while the photograph on the left shows the craters and charred areas after the fires and explosions. Figure 64 shows a still photograph of the fire. Figure 65 show a series of still frames taken from a video of the fire and explosions.

FIGURE 63. Photographs Taken from Scanex Satellite Showing After and Before Views of the Military Depot.

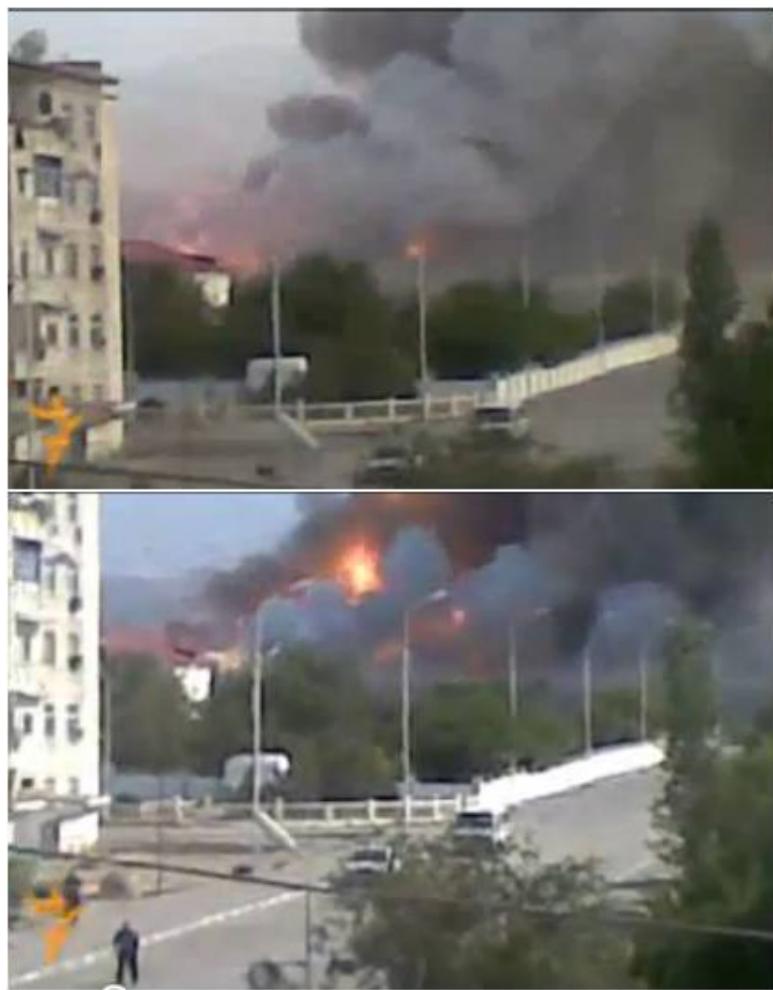
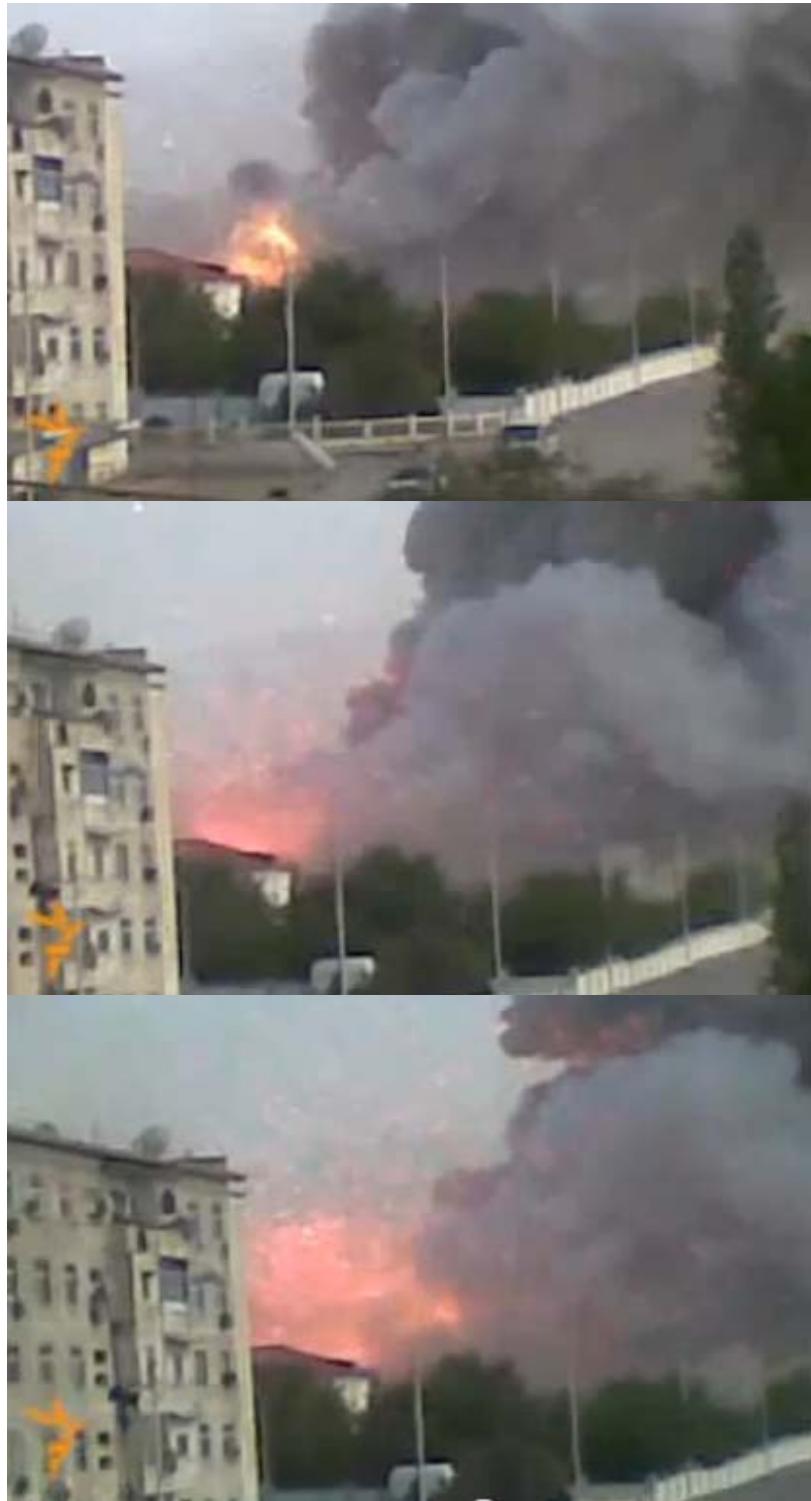
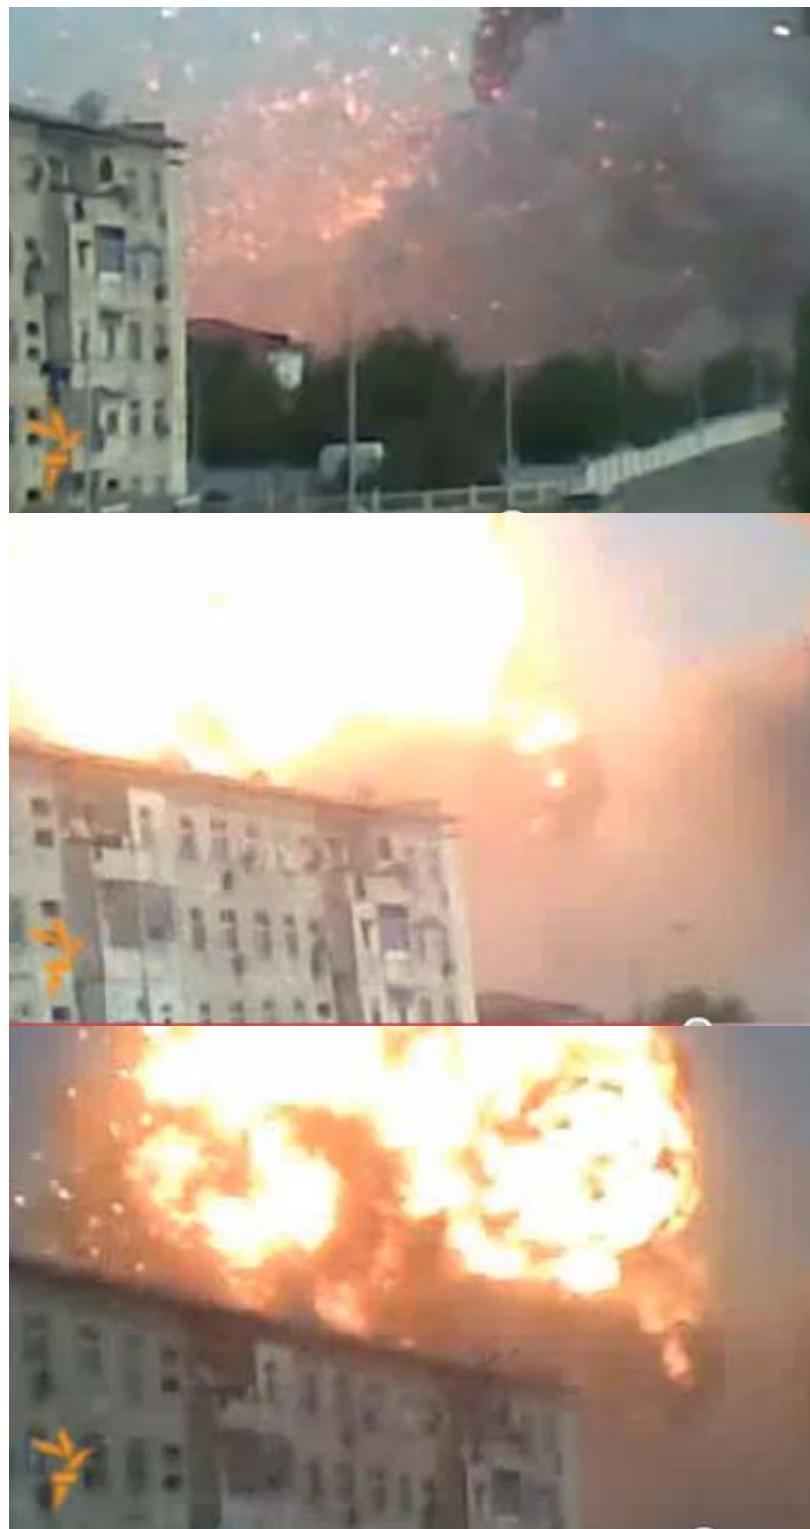
FIGURE 65. A Series of Still Frames Taken From a Video of the Accident in Abadan, Turkmenistan, on 7 July 2011.

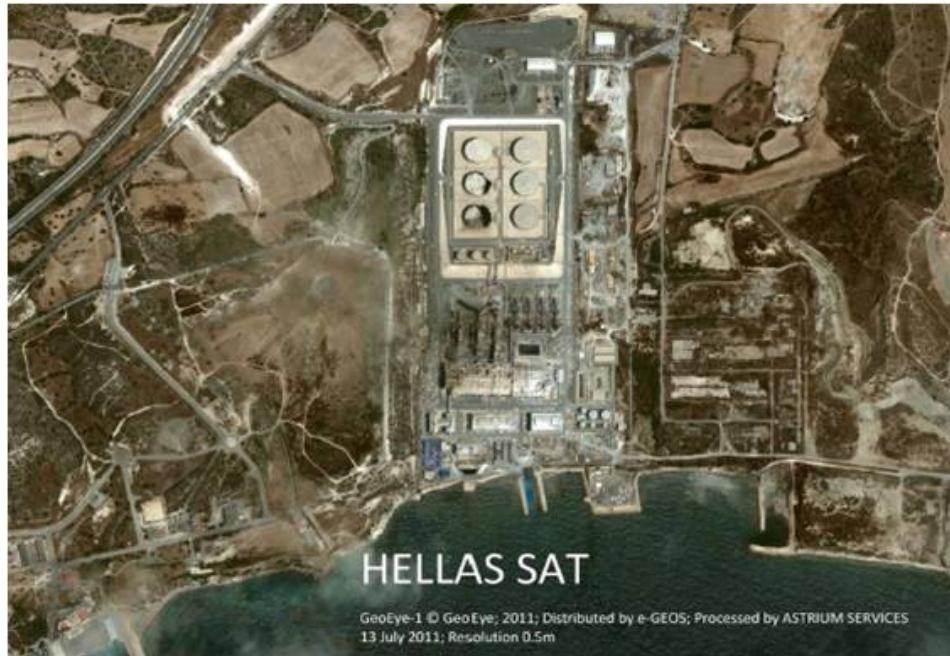
FIGURE 70. Aerial View of the Evangelos Florakis Navy Base and the Vassilikou Power Plant After the Detonations.

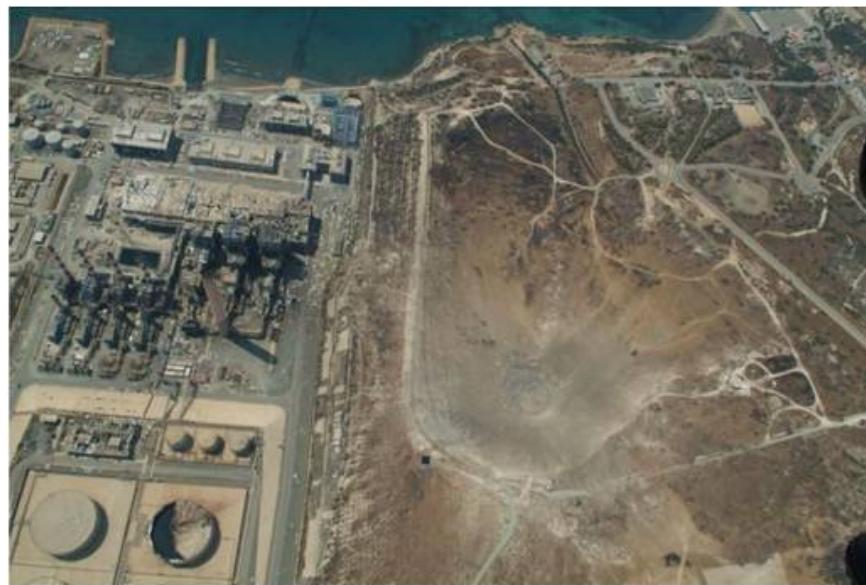
FIGURE 71. High Resolution Aerial View of the Crater Left after the Detonation, and the Resultant Damage to the Adjacent Power Plant.

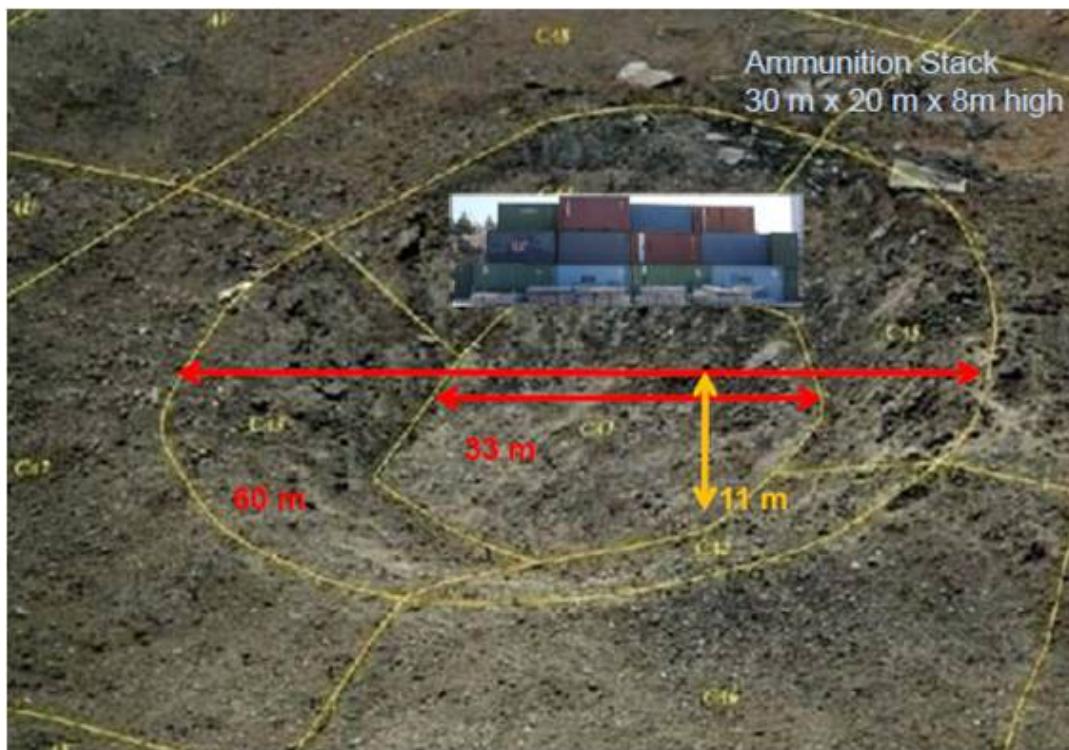
The crater was formed when the gunpowder in 80 of the 98 ISO containers depicted in Figure 67 detonated after the fire had burned more than 2 hours. [Note: In the following discussion, both 80 and 81 are used as the number of ISO containers containing gunpowder. This is because there were 81 containers containing gunpowder when the ISO containers were placed at the Navy base. The contents of one of the containers reacted on 4 July 2011, and the other 80 reacted on 11 July 2011.]

FIGURE 72. Dimensions of the Crater, and Comparison to the Original Stack of ISO Containers.

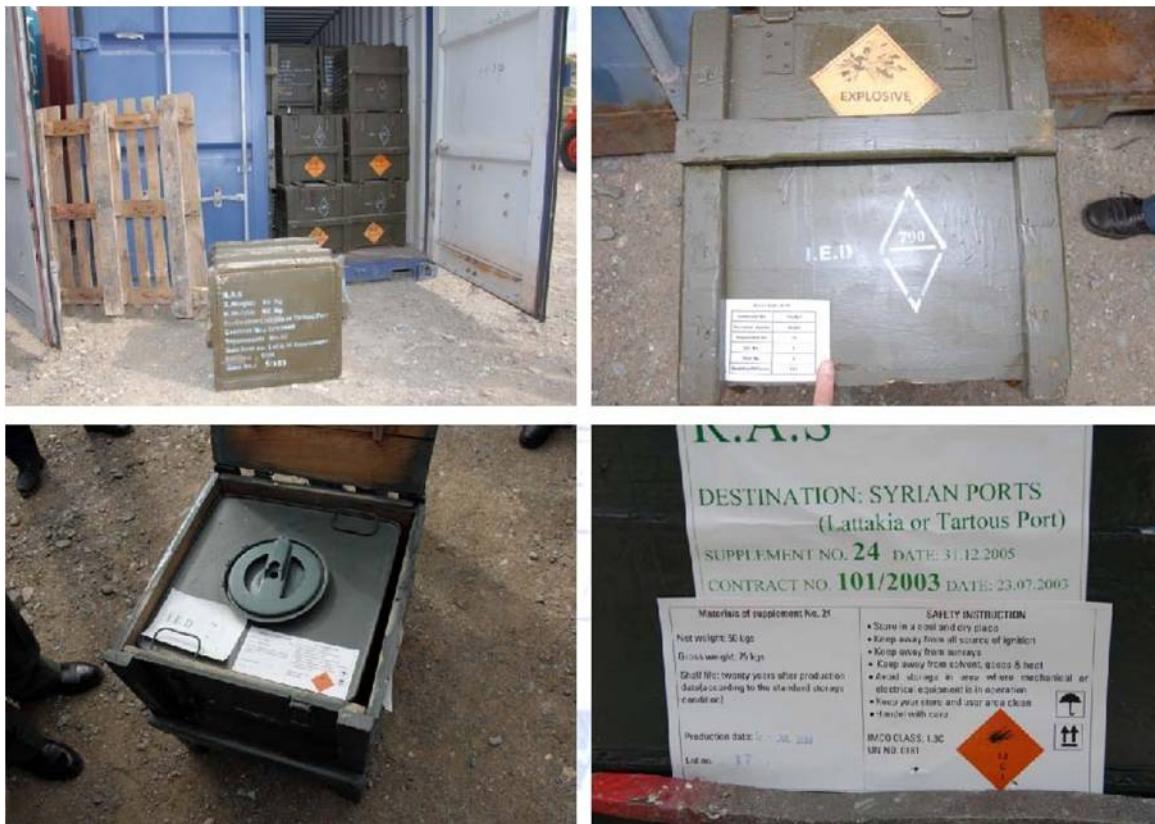
FIGURE 73. Containers of Gun Propellant Contained in ISO Containers.

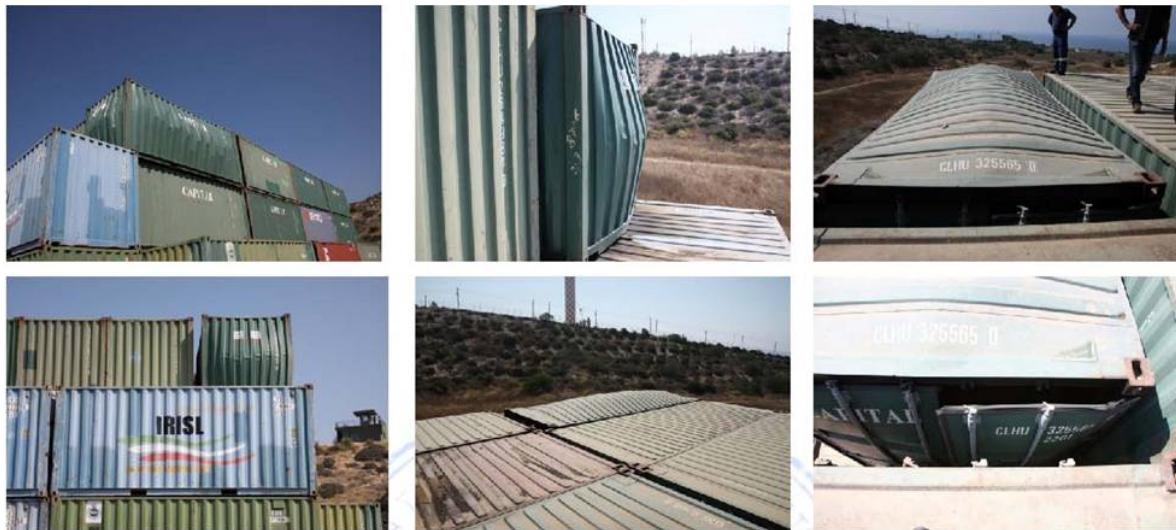
The 98 ISO containers, 81 of which contained gun propellant, were confiscated in January 2009; and on 14 February 2009, the ISO containers were stored on a concrete slab in the open at the naval base. During the day, especially during the summer, the gun propellant in the ISO containers stored in the open got hot. Temperatures in Mari in July typically reach 32 to 33°C. On 11 July 2011, the temperature between 1:00 and 6:00 a.m. in Zygi, adjacent to the Evangelos Florakis Navy Base, was 21.5 to 23.2°C, and the humidity was between 91 and 97%. As discussed earlier in this report in the section on stabilizer depletion and auto-ignition, gun propellants, especially single- or double-based gun propellants, start to decompose when they get hot. As they decompose, the stabilizer gets depleted. Eventually enough stabilizer is depleted so that the decomposition reactions accelerate and ignition of the gun propellant can occur. Once gunpowder starts to burn, the pressure within a closed container rapidly rises and the container may come apart violently, and form and accelerate debris from the container. [The section on tests presents ECMs rupturing producing large pieces of debris one second after ignition of gun propellant.] Could that have happened at Evangelos Florakis Navy Base, Cyprus? Yes. As mentioned above, one week before the 11 July 2011 detonations, on 4 July 2011, one ISO container was discovered with evidence of reaction and fire. Figure 74 shows the ISO container with

bulged walls and roof, and the doors blown partially open. The force of the reaction was sufficient to move the 10.5-ton ISO container approximately 30 cm in two directions as shown in Figure 74.

FIGURE 74. ISO Container in the Stack Showing Evidence of Reaction and Fire by the Bulging Walls and Roof and the Door That Has Been Blown Partially Open. The force of reaction moved the ISO container approximately 30 cm in two directions.

When propellant decomposes porosity is produced in the propellant. Propellant with porosity or voids is usually significantly more sensitive to mechanical shock to detonation transition than undamaged material. That is, it does not take as much input shock level to initiate detonation in the damaged material as it does in undamaged material. While the undamaged gun propellant originally may have truly been HD 1.3 as per UN tests, the damaged material that had been in ISO containers sitting in the hot sun for 2+ years may not have been HD 1.3 any longer. The storage of gun propellant in a stack of ISO containers in the hot sun may have been a recipe for disaster.

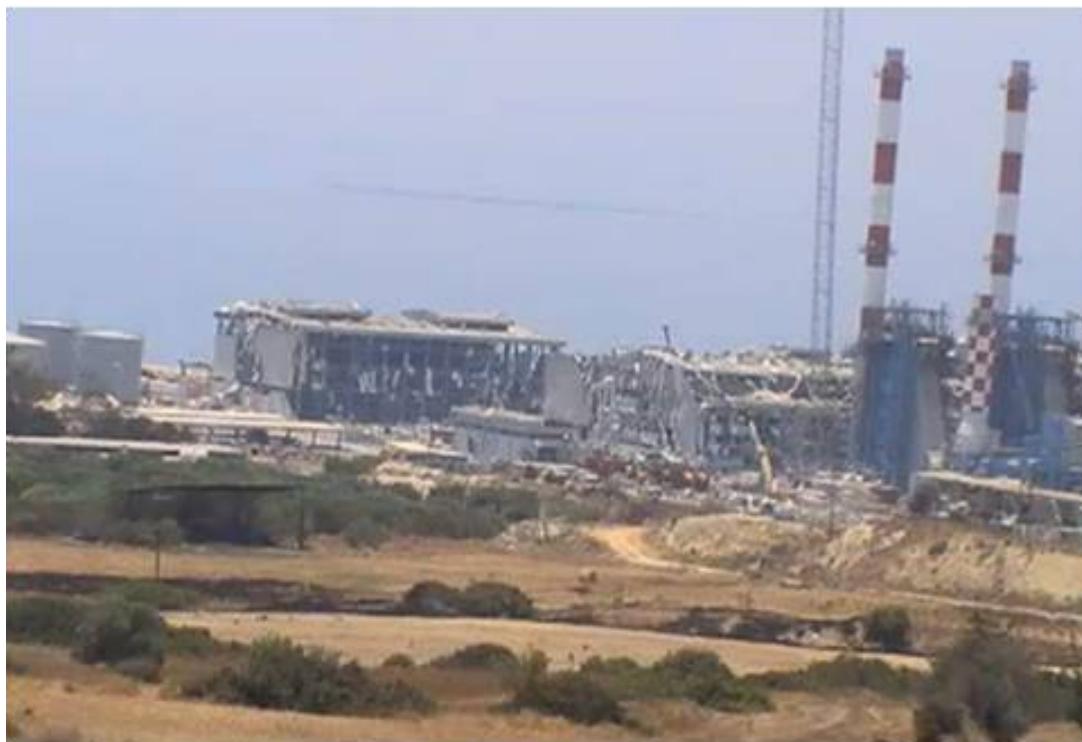
FIGURE 75. Damage to Vassilikou Power Plant.

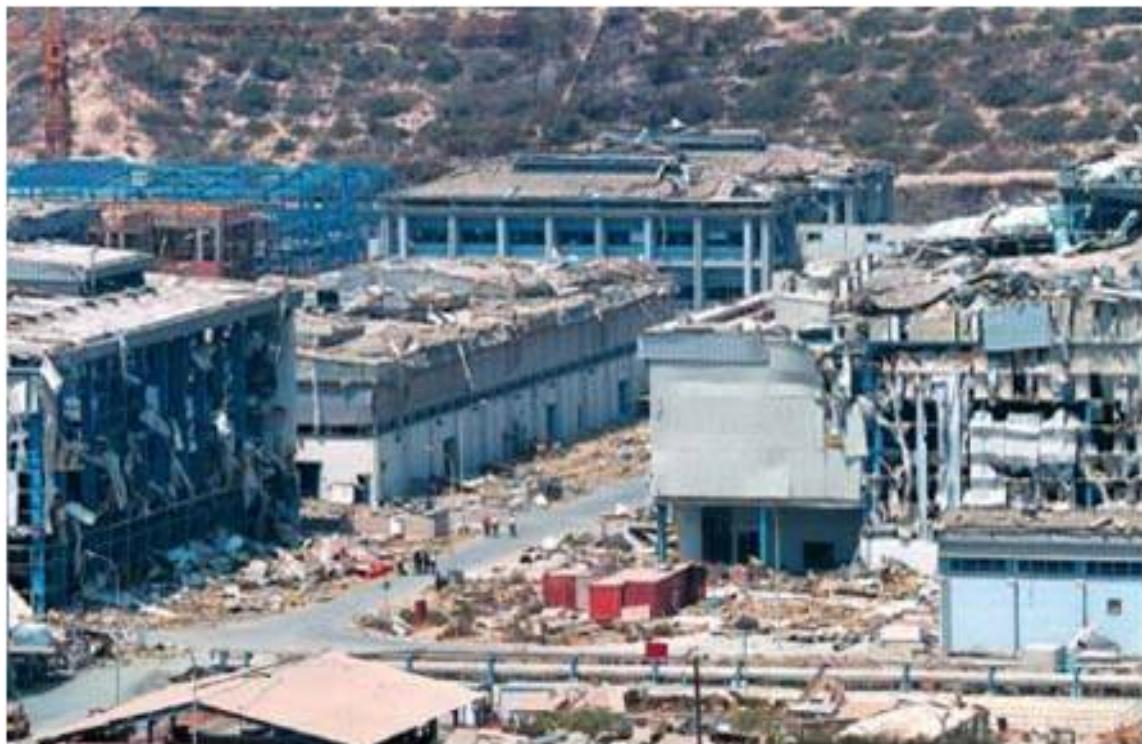
FIGURE 76. Damage to Vassilikou Power Plant.

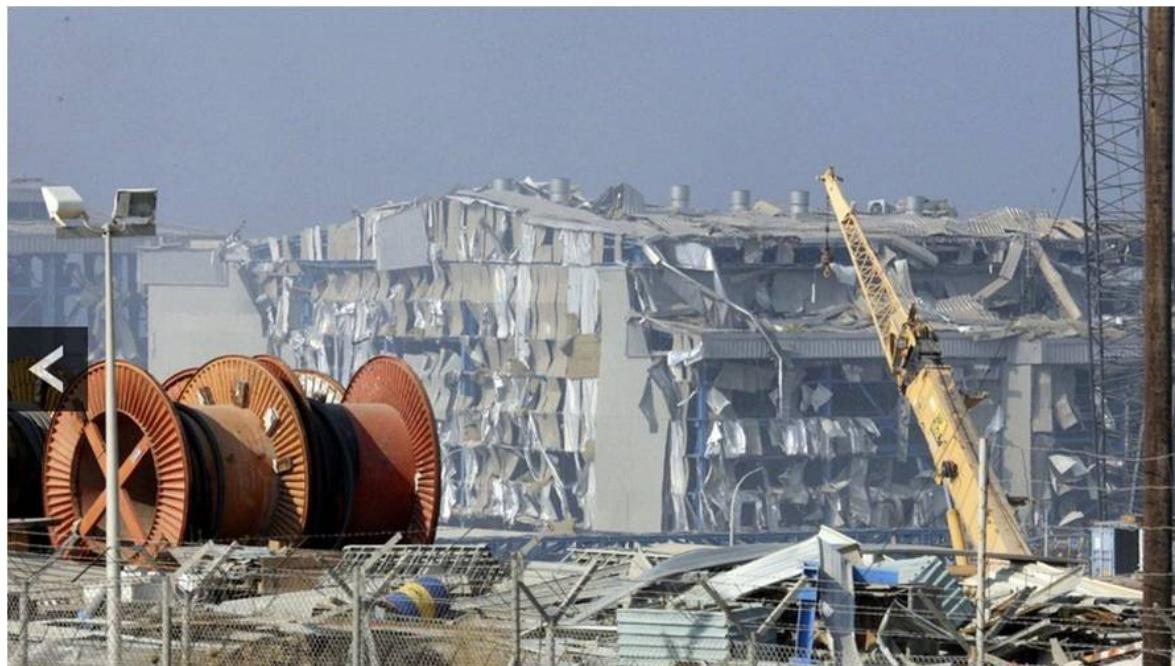
FIGURE 77. Damage to Vassilikou Power Plant.

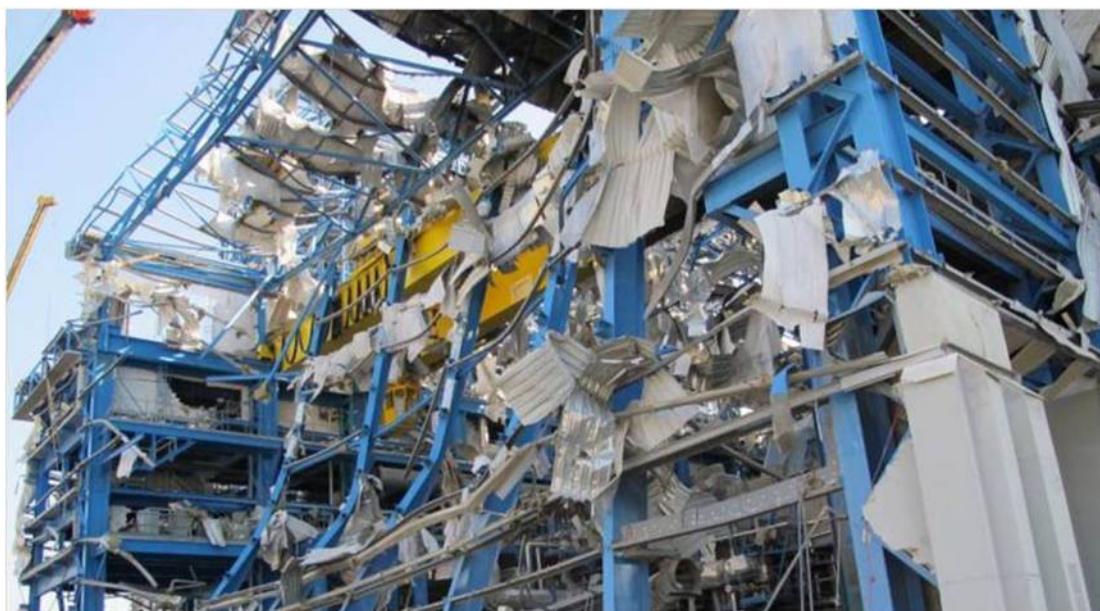
The disaster was not limited to the Navy base. As shown in the aerial view of Figures 68 and 69, the Vassilikou Power Plant was immediately adjacent to the Navy base. Figures 75 through 79 show the considerable damage to the power plant.

FIGURE 78. Damage to Vassilikou Power Plant.

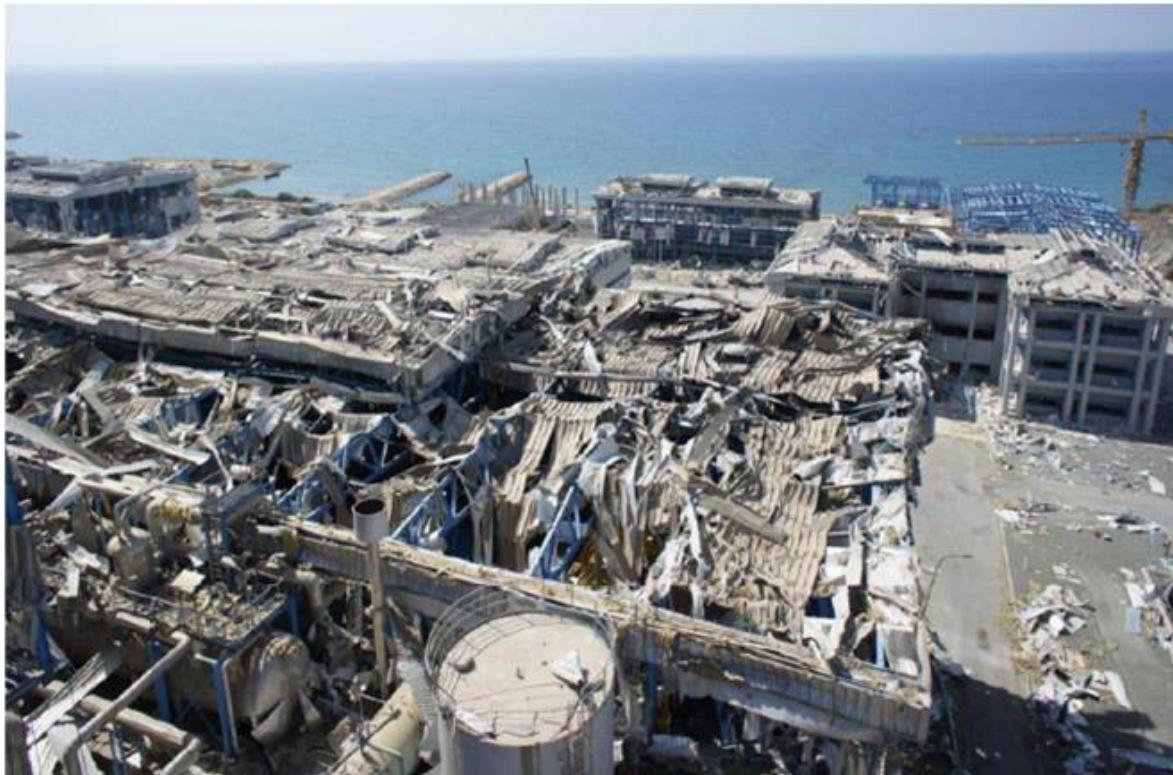
FIGURE 79. Damage to Vassilikou Power Plant.

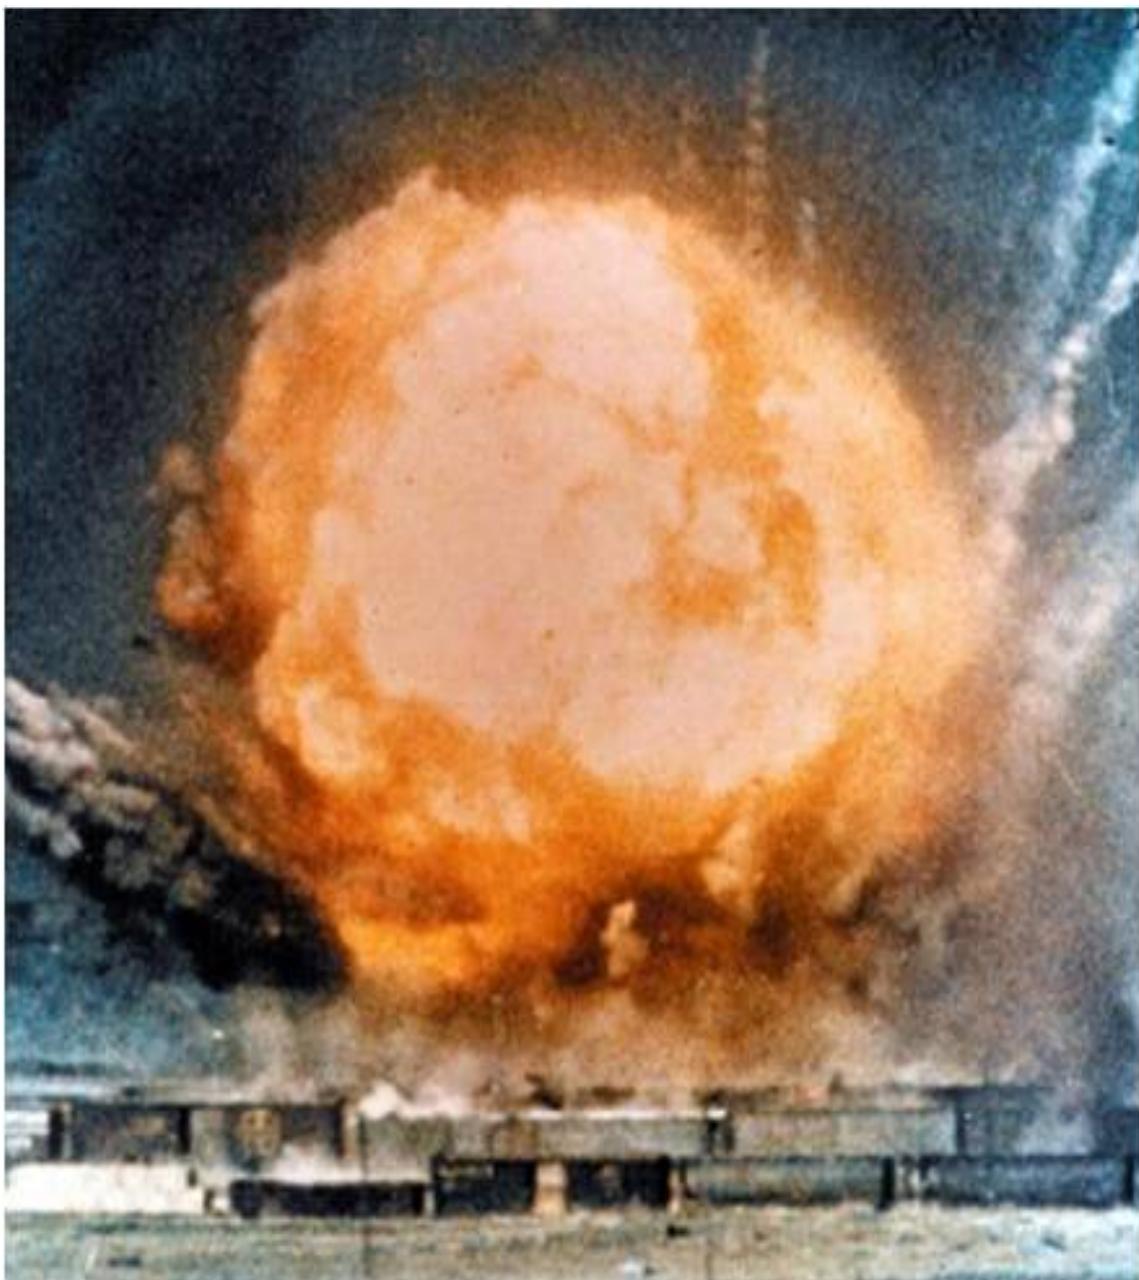
The other 17 cars at the west end of track 7 exploded at various intervals until approximately 10:30 a.m. Bombs strewn in burning debris exploded intermittently until 4:05 p.m. the following day. Figures 81 through 85 present photographs taken of the events and the aftermath of the accident.

FIGURE 81. Accident at Roseville Railyards, 28 April 1973.

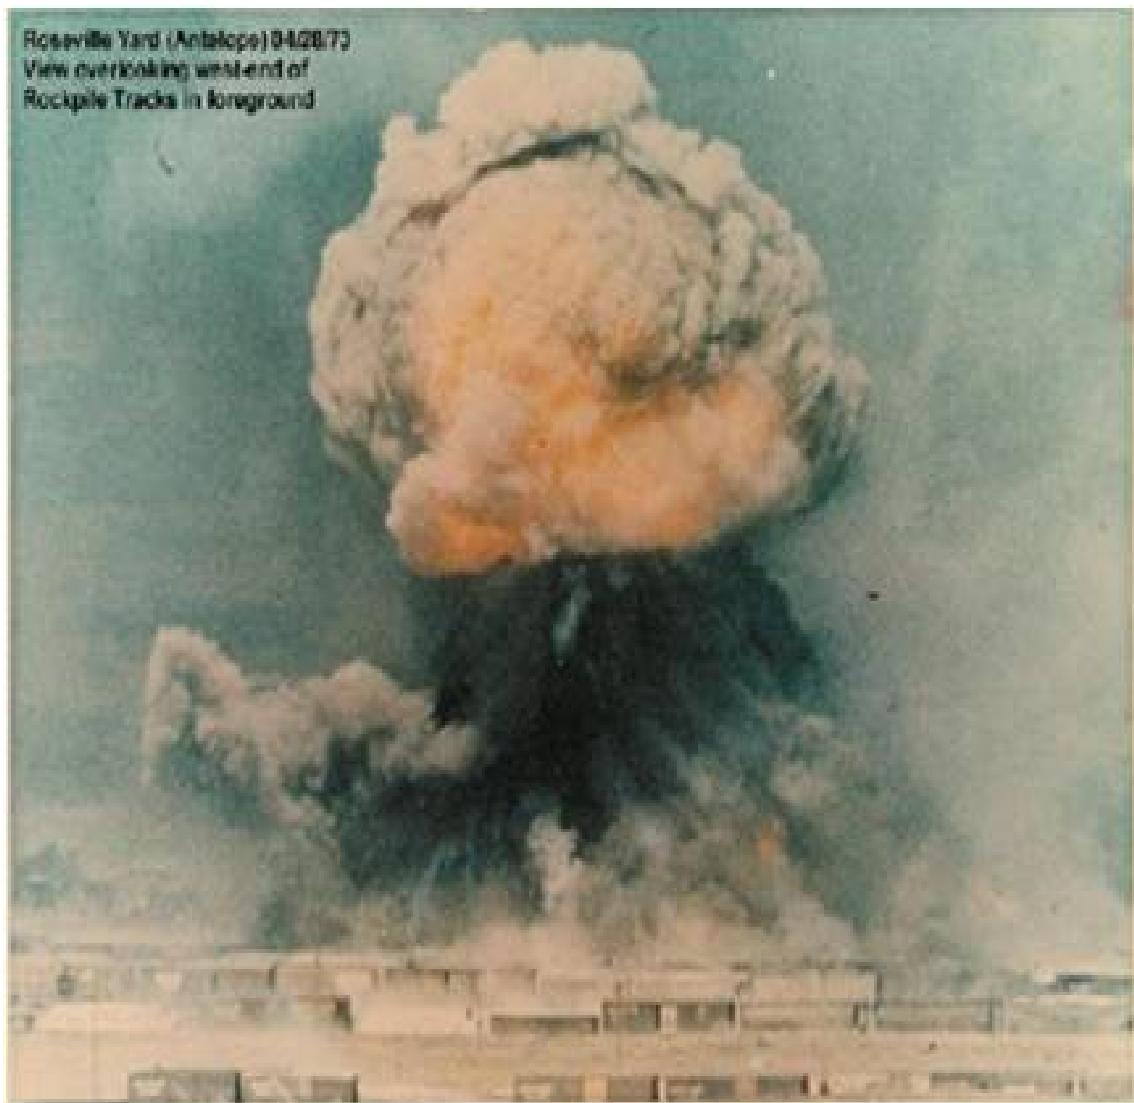
FIGURE 82. Accident at Roseville Railyards, 28 April 1973.

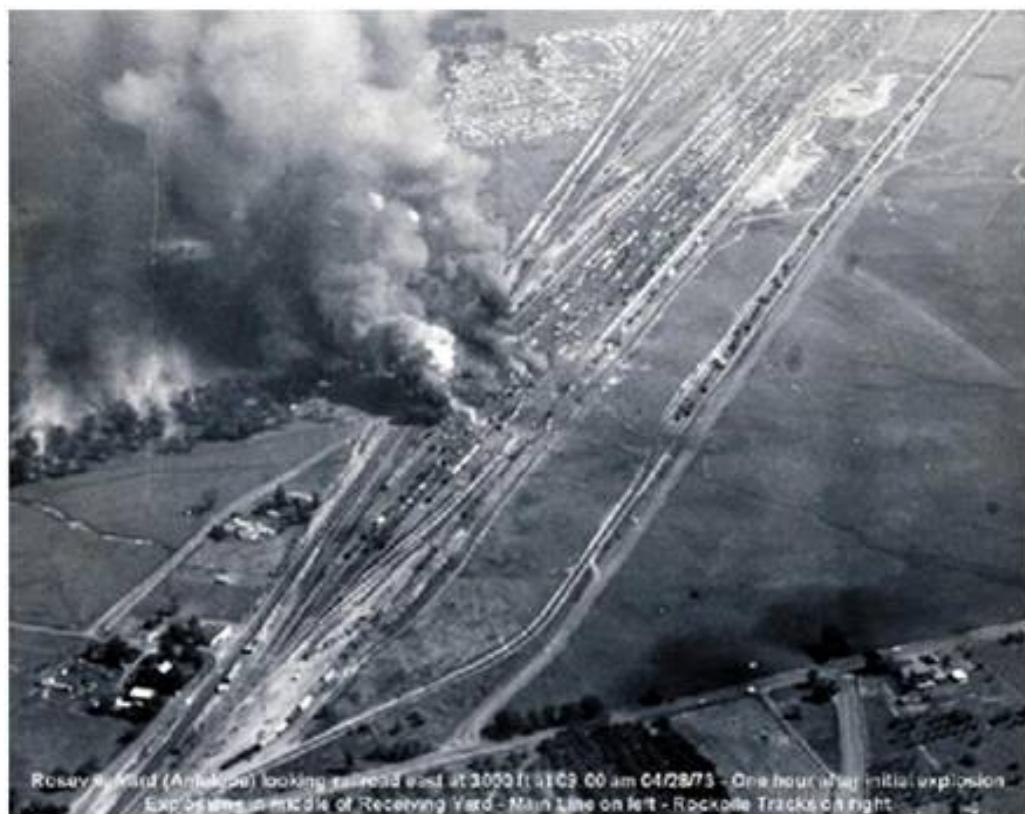
FIGURE 83. Aerial View of Accident at Roseville Railyards, 28 April 1973.

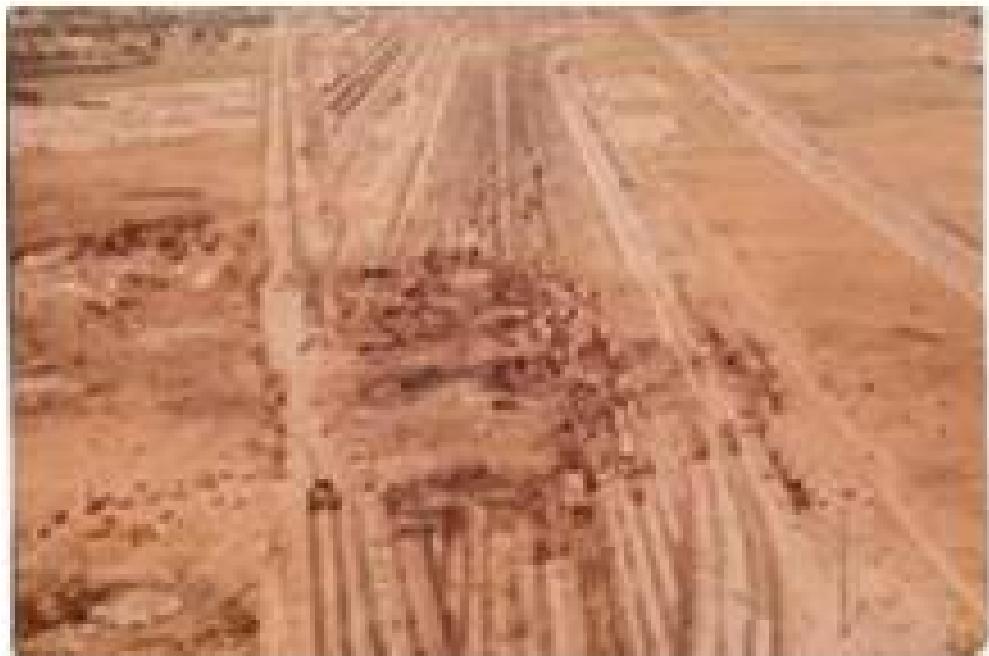
FIGURE 84. Aerial View Showing Damage at Roseville Railyards, 28 April 1973.

Fortunately, there were no fatalities, but 15 Southern Pacific employees and approximately 335 residents were injured. Approximately 5,500, mostly residential, buildings were damaged by the explosions. There were 169 freight cars destroyed and 98 freight cars and one locomotive damaged. The cost of damages and casualty claims were estimated to be \$23 million.

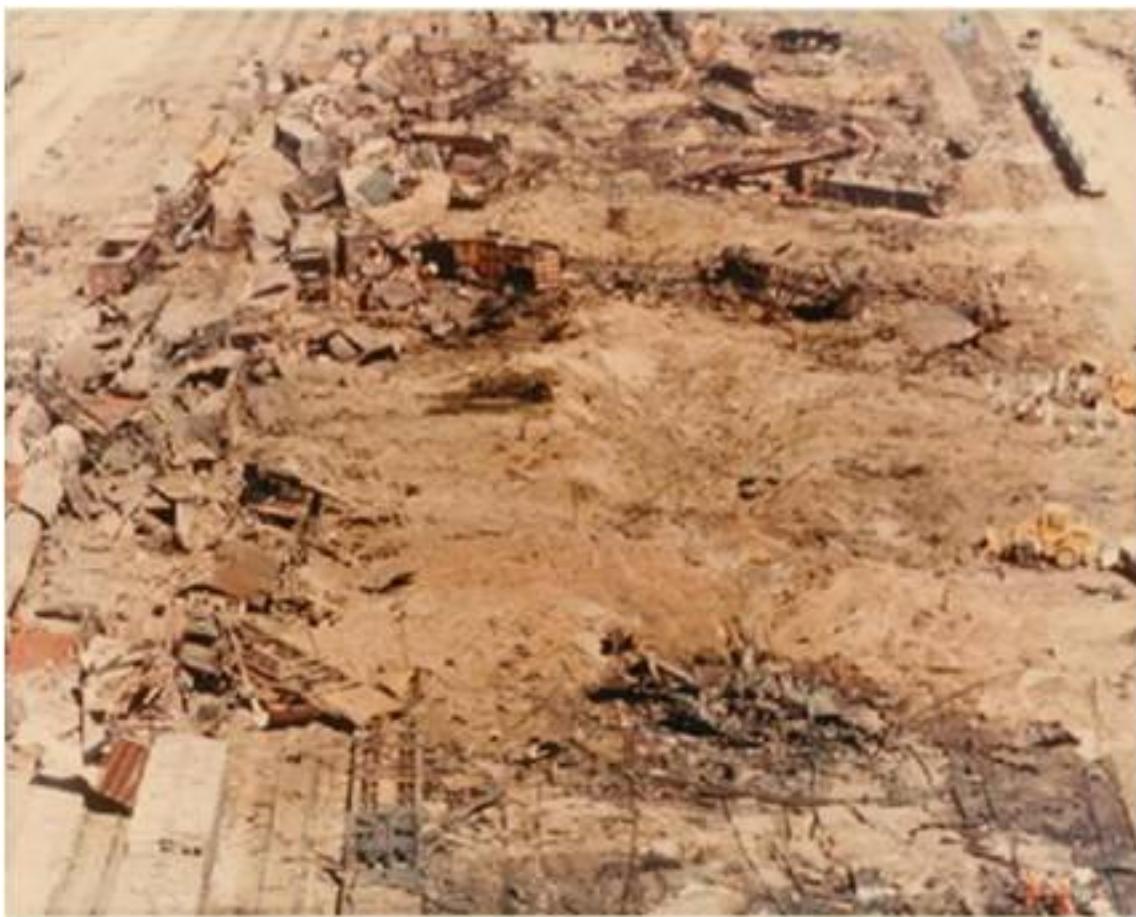
FIGURE 85. Aerial View Showing Damage at Roseville Railyards, 28 April 1973.

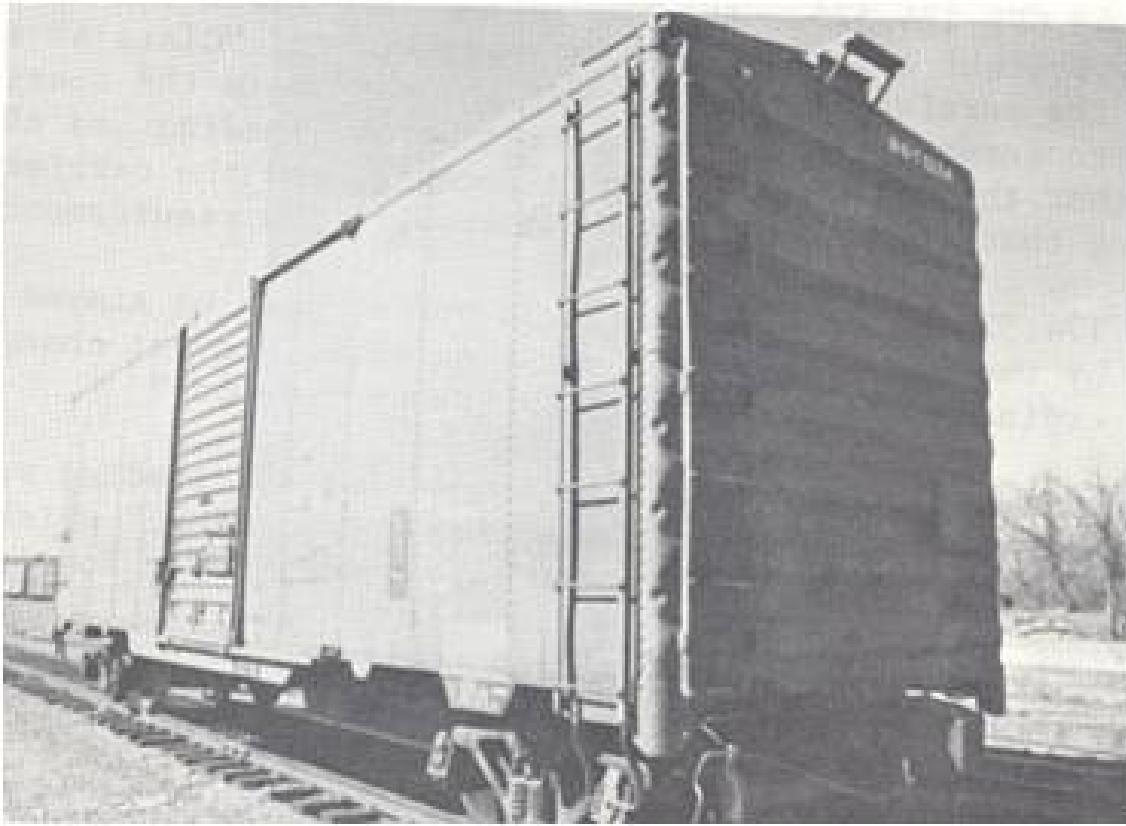
Figure 86 shows a railcar very similar to boxcar 38. Note that the car has truck assemblies (a swiveling frame with two or more axles with pairs of wheels) at front and rear of the boxcar. Later discussions will focus on sparks from the brakeshoes acting on the wheels causing the fire.

FIGURE 86. Railcar Very Similar to Boxcar 38 Involved in Accident Near Benson, Arizona, 24 May 1973.

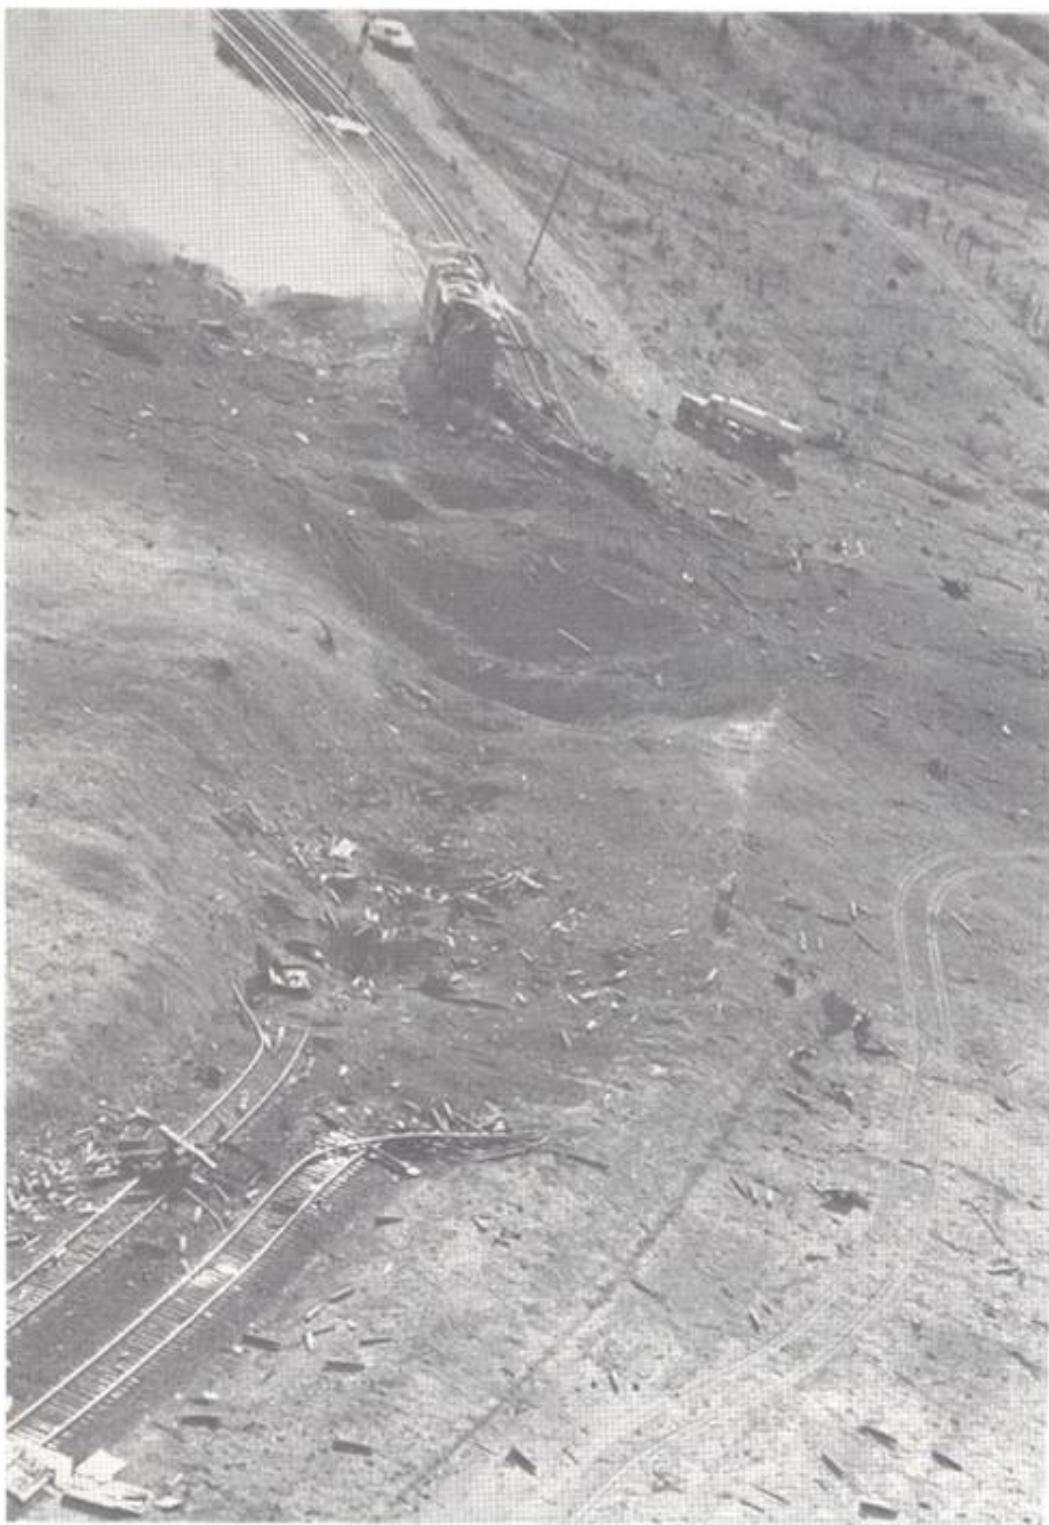
FIGURE 87. Aerial View Showing the Damage From the Accident Near Benson, Arizona, 24 May 1973.

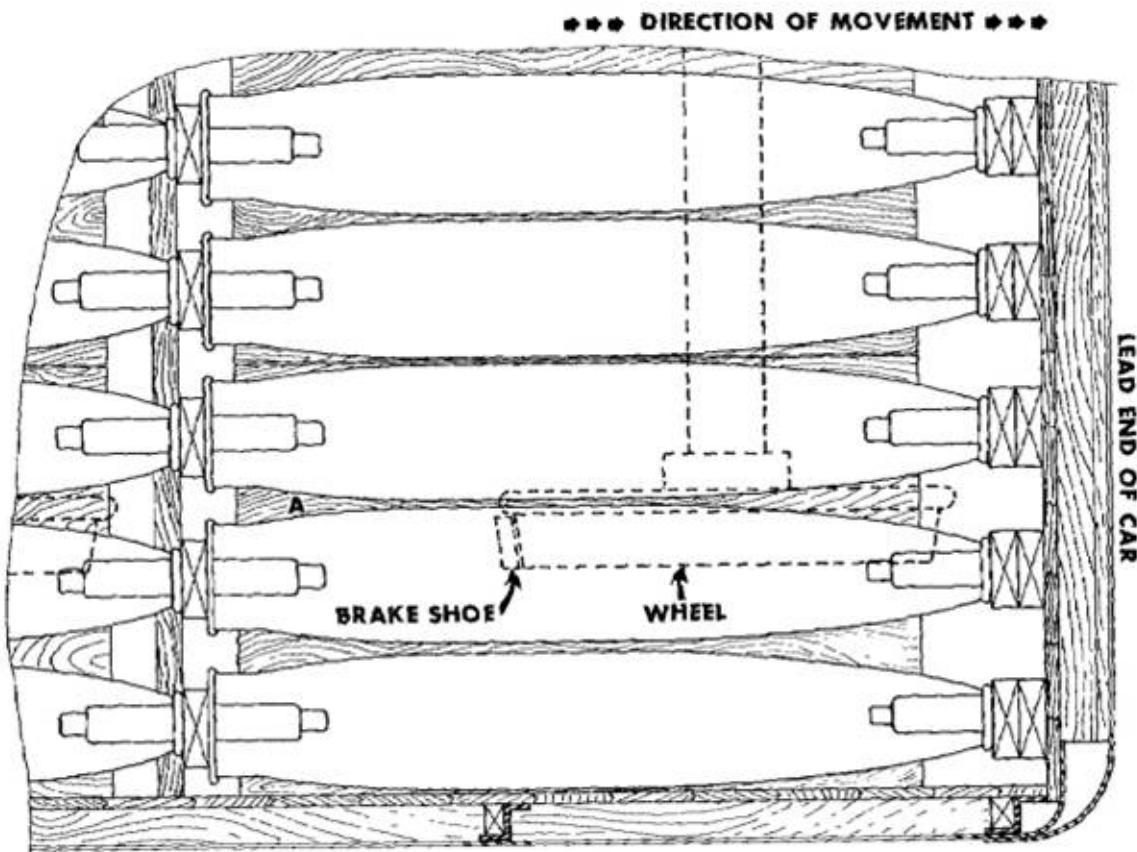
The cause of the accident was attributed to fire in car 38. It was estimated that part of the flooring below a pallet that contained bombs was exposed to fire of 1,500°F for 25 minutes. The fire was located almost directly above an area where sparks from the brake shoes could impinge on the floorboards. There were no spark shields on this car. The location of bombs and the location of the front wheel on the front truck are shown in Figure 88.

FIGURE 88. Schematic Showing Location of Bombs Over the Brake Shoe/Wheel of the Railcar for Railcar 38.

The ignition of the floorboards was facilitated by the presence of sodium nitrate. Records show that car 38 had carried 400 100-pound bags of sodium nitrate on 28 April 1972. During transit, 21 bags had broken open. On 12 June 1972, an inspection of this car at Ray, Texas, revealed that it had been damaged by fire. It was not repaired until April 1973. The interior of the car had been washed with water before it left M-K-T shops on 5 May 1973. Analysis of some of the burned boards from boxcar 38 showed sodium nitrate levels from 3% at the surface to 0.10% a half inch into the board. The floorboards also were impregnated with oil. Once the floorboards were ignited, the sodium nitrate and oil sustained the burning of the floorboards.

Additional support for fire caused by brake shoe sparks impinging on the wooden floor of the railcar enabled by the absence of spark shield, and abetted by contamination of the wooden floor boards by sodium nitrate and oil, was provided by a review of the history of car fires experienced by Southern Pacific in this district. Of the 237 car fires reported in the previous five years, 77% resulted from brake shoe sparks. The reports included a 16 December 1972 accident where a car transporting Mk 82, 500-pound bombs caught fire at Hughson, California, as a result of "dragging brakes."

- Because of the possibility of wooden floors igniting and burning, later cars were constructed with steel flooring.
- Instead of all of the cars carrying munitions being consecutive, "spacer" cars not carrying munitions, should be inserted between cars carrying munitions.
